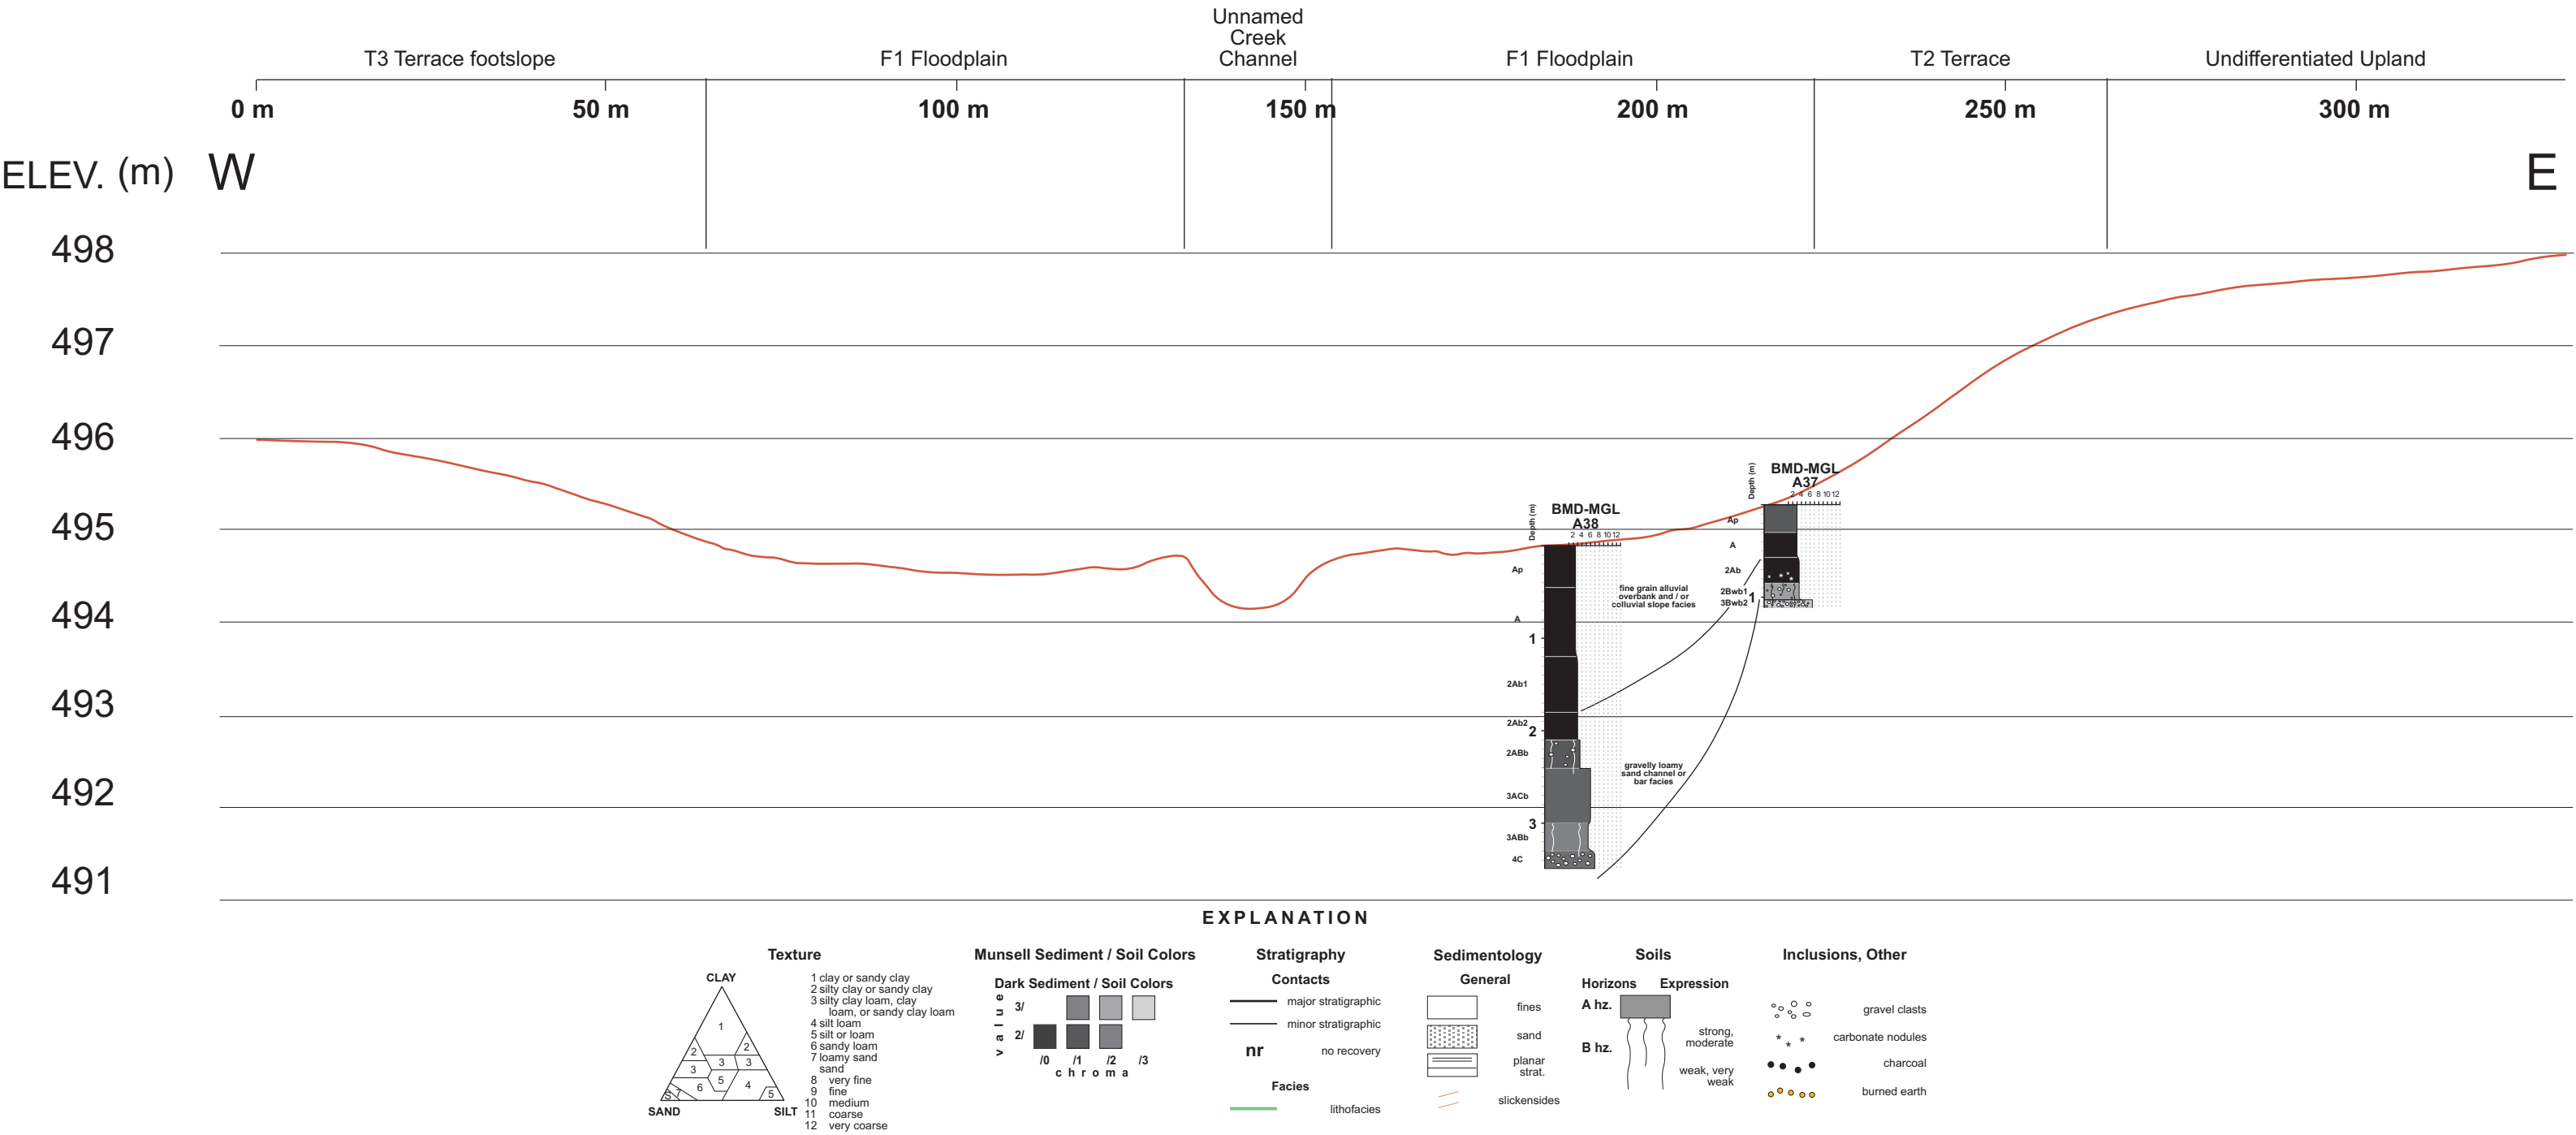
Figure 22 Graphic sediment soil logs and stratigraphic profile with lithofacies of surfaces in unnamed creek valley at RA-02 route terminus.
