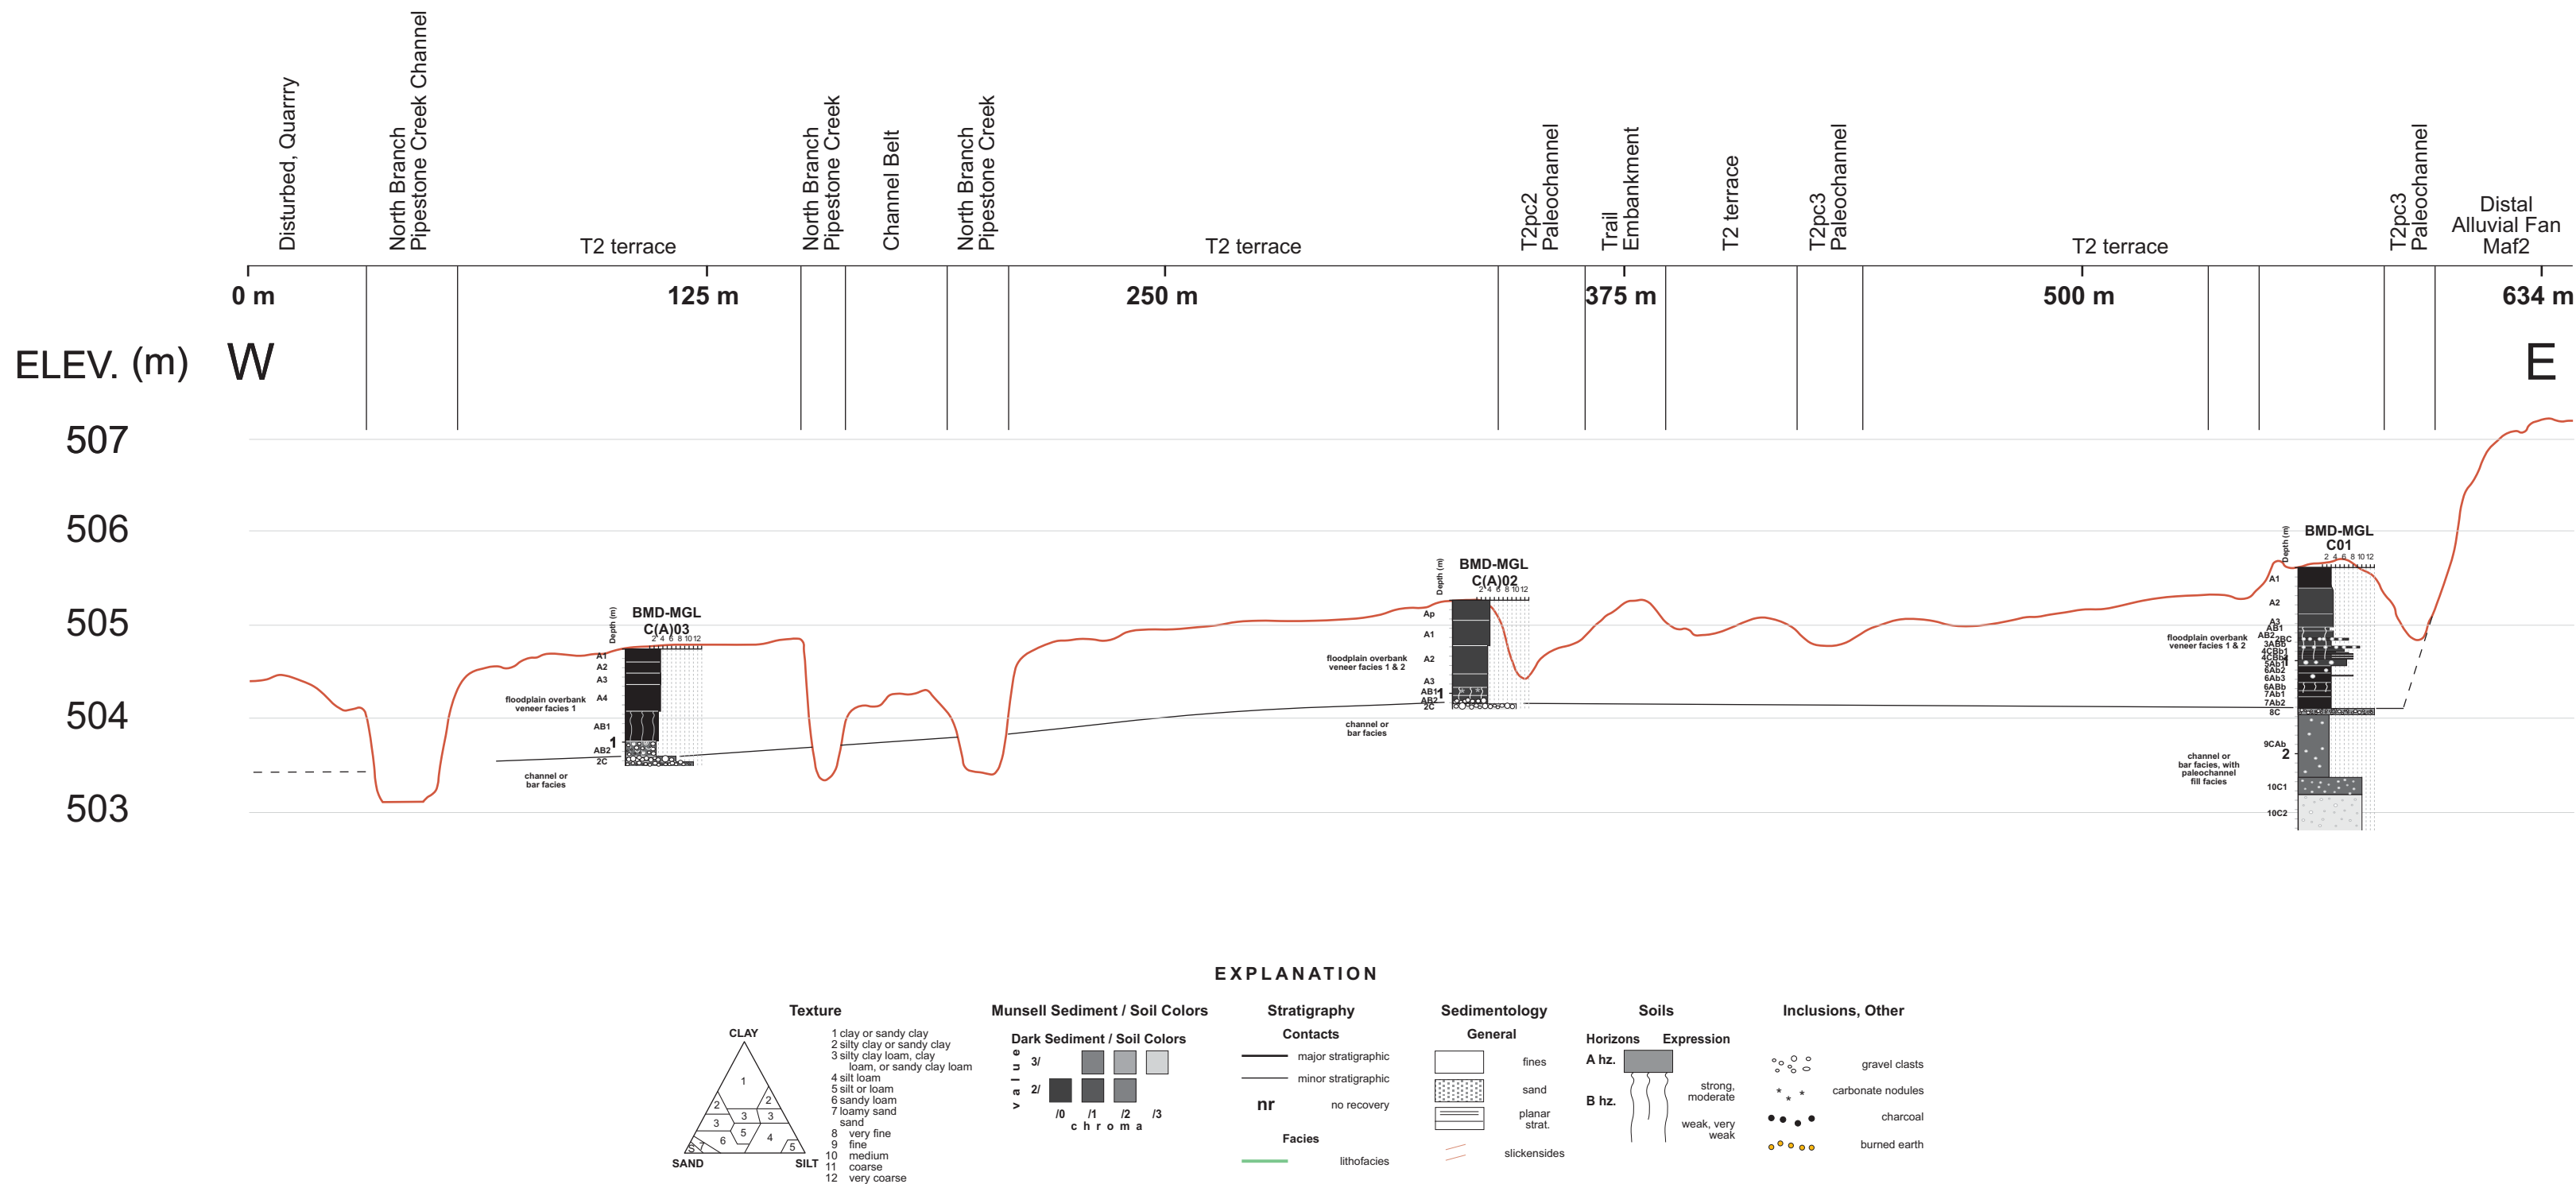
Figure 4 Graphic sediment soil logs and stratigraphic profile with lithofacies across Northern Branch Pipestone Creek Valley profile north of 151st Street.
